NASA Unmanned Flight Anomaly Report:

INVESTIGATION OF MECHANICAL ANOMALIES AFFECTING INTERPLANETARY SPACECRAFT

September 1994

Jet Propulsion Laboratory
California Institute of Technology
Pasadena, California

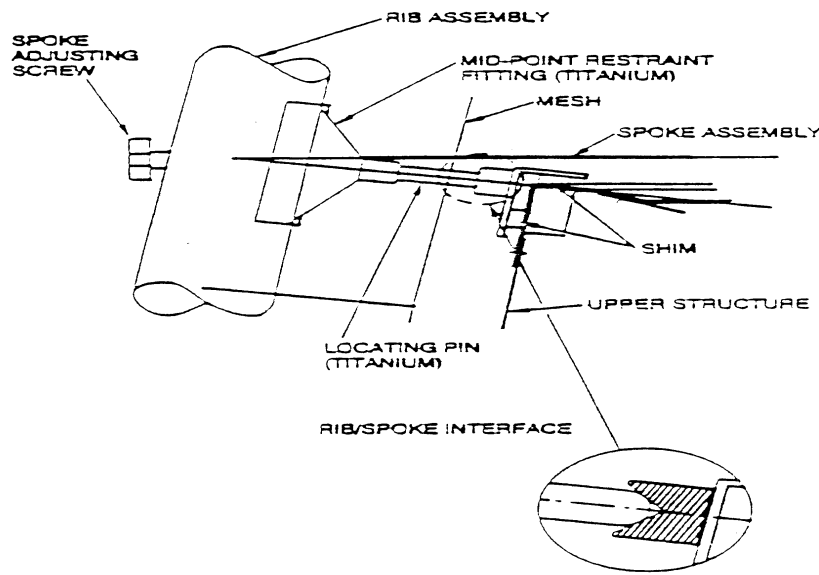
The failure of these efforts led analysts to believe that several stuck ribs were restrained at the pin and socket fittings, provided at the midpoint of the antenna ribs to prevent flexing during launch. This midpoint restraint features two pins with spherical ends reacting against an 85 lb. preload on the spoke. One pin engages a conical socket and the other a V-groove socket. This V-groove was a JPL innovation; both sockets on the original TDRS design were conical. Figure 2 illustrates the location of the fitting within the rib-spoke interface.

After a two-year investigation at JPL, the failure mechanism was isolated to friction in the midpoint restraint pin/socket interface. Preloading of the ribs when stowed at the factory damaged the V-groove pin ceramic coating, which served as the bonding surface for the dry lubricant. Accumulated stresses from vibration testing, rib preloading, four cross-country trips, and post-launch ignition of the upper stage further dispersed the lubricant film. Due to the resulting friction, some ribs required more force than the drive motors could generate, causing asymmetrical deployment and restraining forces which further reduced the torque available from the drive system. Workarounds using an LGA, new data compression techniques, and the spacecraft's recorder are expected to meet 70 percent of the mission objectives.

Rib/Spoke Interface
